Test Report No.: **01 220 CHN/T-1904977**

Test Report

Sample name: BONOSS WHEEL BOLTS

Other information: Product specification: M14×1.5, Property class 12.9;
Material and Mark: SCM440.

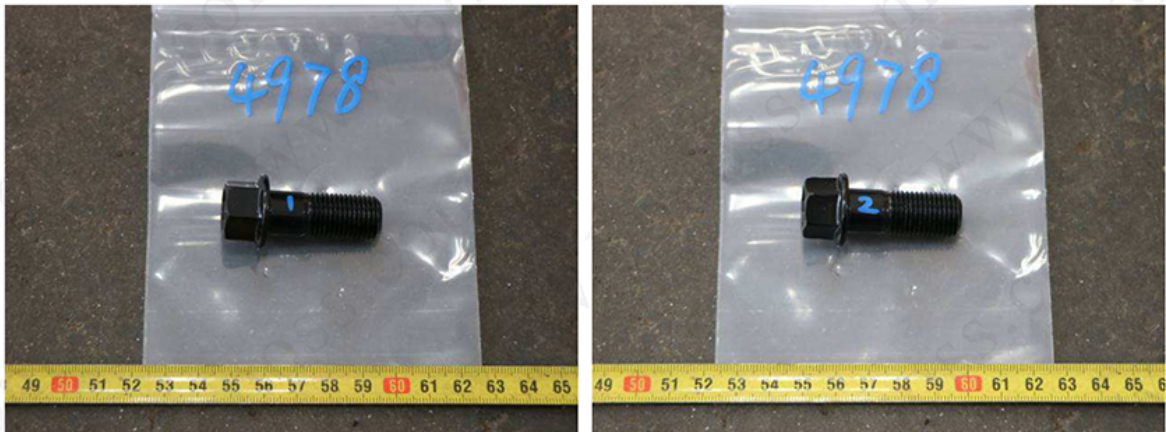
Sample description: Two pieces of bolts

Other information: Product specification: M14×1.5, Property class 12.9;
Material and Mark: SCM440.

Sample	Hardness scale	HV(1)	HV(2)	Requirement	Conclusion
1#	HV0.3	404	405	HV(2)≥ HV(1)-30	No decarburization

Sample	Hardness scale	Before retempering			After retempering			Reduction of hardness after retempering
2#	HV10	398	405	396	387	386	390	12

Sample	Hardness scale	Test position	Result		
1#	HV10	1d back from the end of the thread, half-radius area	395	402	400

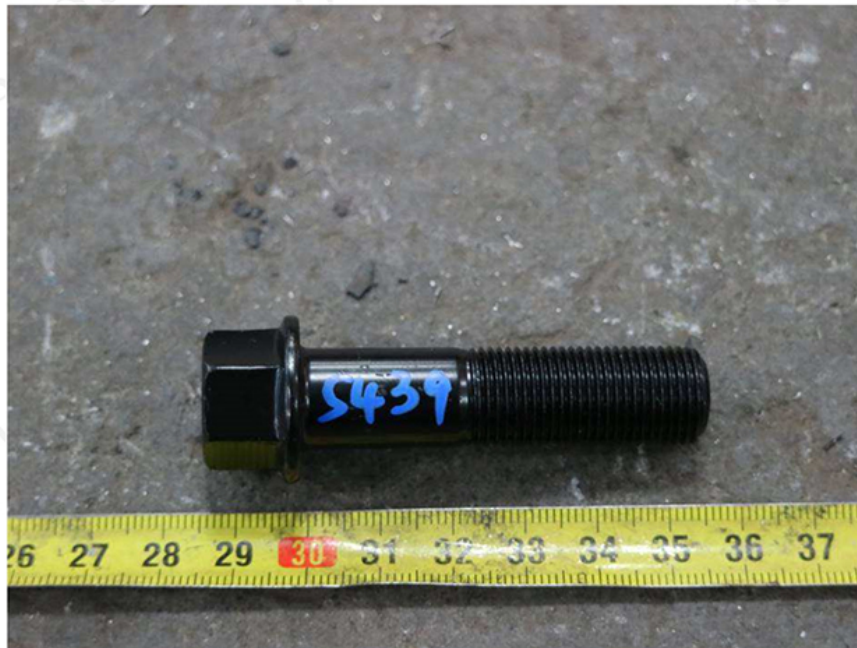
Other information: Product specification: M14×1.25;
Material and Mark: SCM440.

Element	C	Si	Mn	P	S	Cr	Ni	Mo	Cu
Result,%	0.41	0.19	0.74	0.013	0.005	1.01	0.021	0.20	0.037

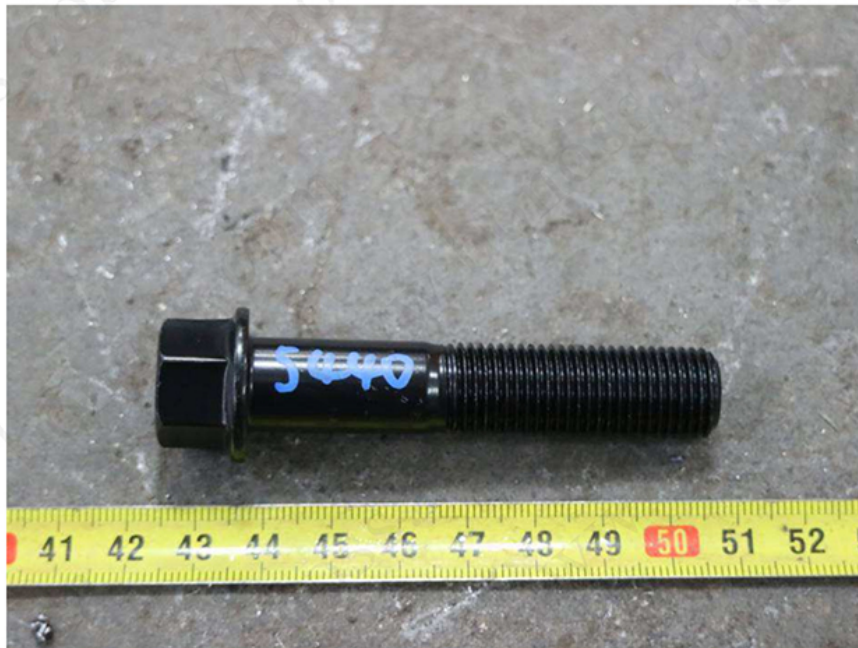
Other information: Product specification: M14×1.5;
Material and Mark: SCM440.

Element	C	Si	Mn	P	S	Cr	Ni	Mo	Cu
Result,%	0.42	0.22	0.69	0.018	0.005	0.96	0.026	0.16	0.033

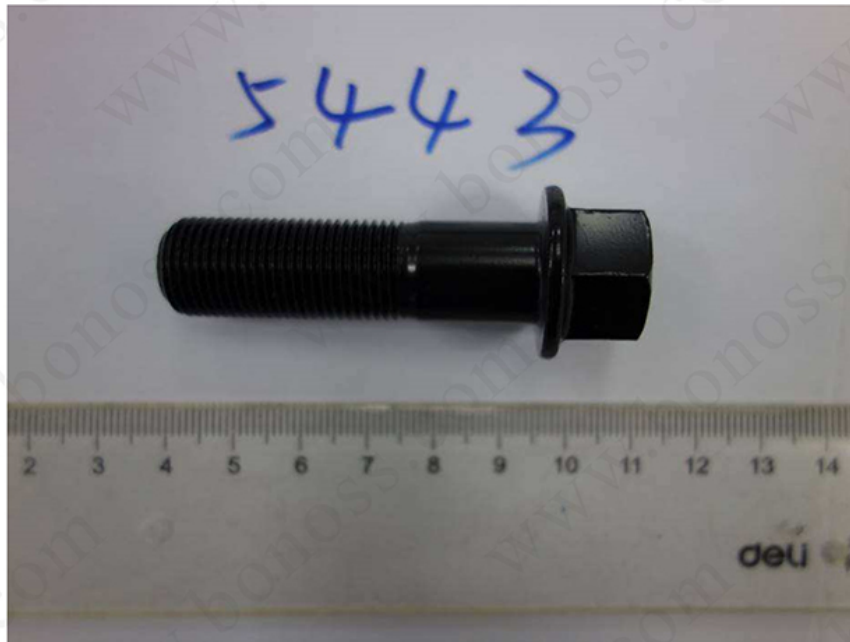
Other information: Material and Mark: SCM440.

Exposure period (h)	The area of defect, A(%)	Appearance rating(R _A)	Description of appearance
192	/	/	Red rust occurred on the test surface.
240	50 < A	0	Red rust occurred on the test surface.

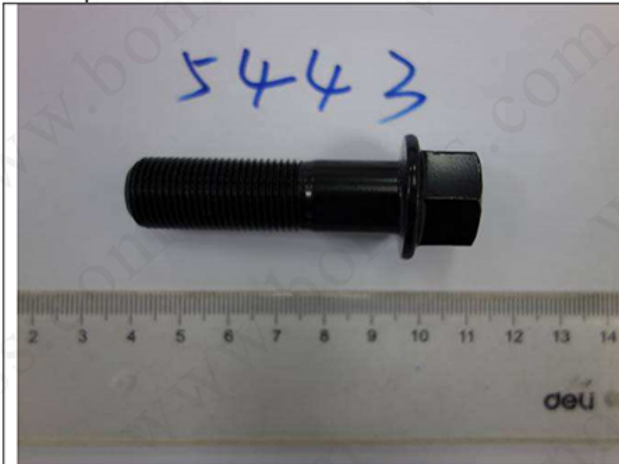
Before test

Neutral salt spray test:
