Test Report No.: 01 220 CHN/T-2500960

Test Report

Sample name: BONOSS Wheel Spacer

Other information: Material and Mark: Aluminum 6061-T6.

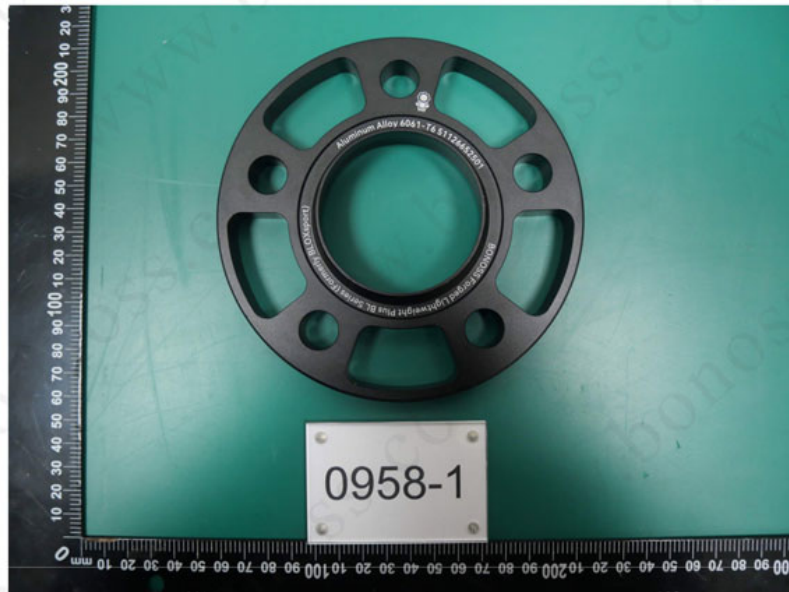
Sample photo(s):

Sample name: BONOSS Wheel Spacer

Sample description: A piece of aluminum product

Other information: Material and Mark: Aluminum 6061-T6.

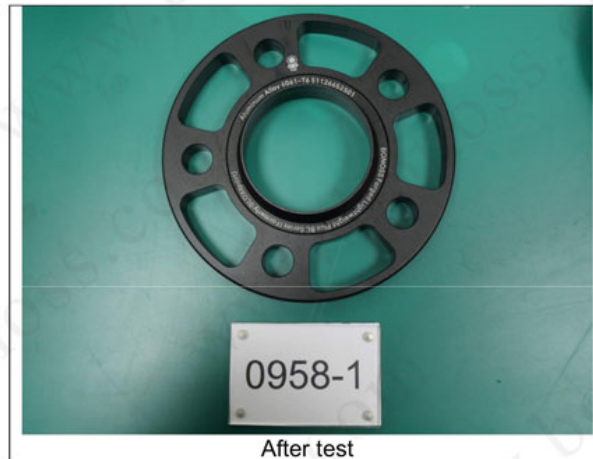
Test photos:

Neutral salt spray test:

Test method: ISO 9227:2022+Amd 1:2024

Sample	Exposure period (h)	Description of appearance
1#	240	No defects.

After test

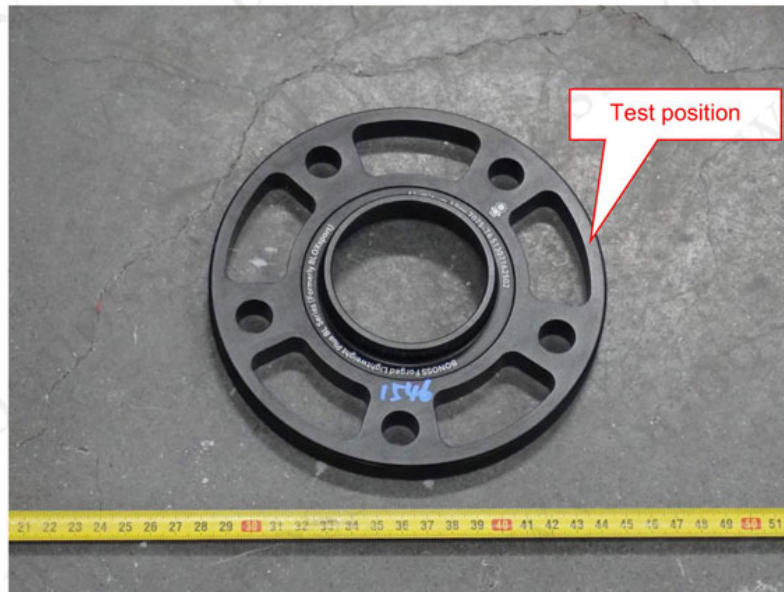
Sample photo(s):

Sample name: BONOSS Wheel Spacer

Sample description: A piece of aluminum product

Other information: Product specification: AL7075T6-15mm;
Material and Mark: Aluminum 7075-T6.
