Test Report No.: **01 220 CHN/T-2000114**

Test Report

Sample name: BONOSS WHEEL STUDS

Other information: Product specification: M14*1.5, 12.9;
Material and Mark: SCM440.

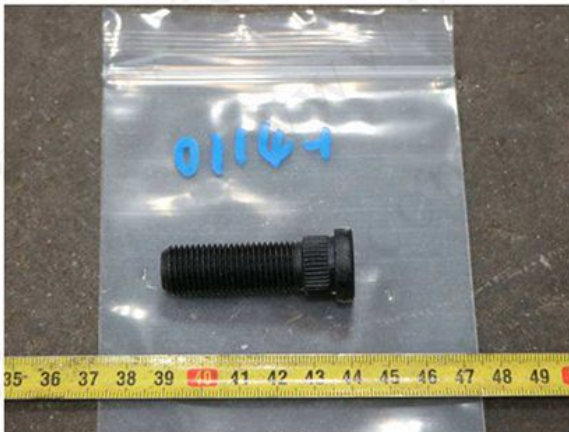
1#

Sample description: Three pieces of steel bolts

Test item	Result Tensile strength (N/mm ²)
Result-1#	1233 The fracture occurred in the free threaded length.

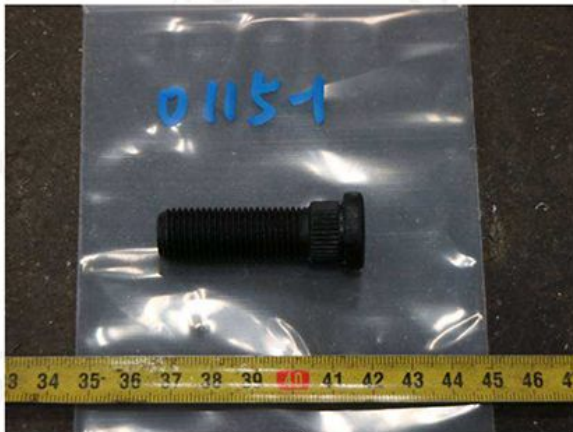
Sample description: Two pieces of steel bolts

Other information: Product specification: M14*1.5, 12.9;
Material and Mark: SCM440.

Sample	Hardness scale	HV(1)	HV(2)	Requirement	Conclusion
1#	HV0.3	388	386	HV(2)≥ HV(1)-30	No decarburization

Sample	Hardness scale	Test position	Result		
1#	HV10	1d back from the end of the thread, half-radius area	390	386	386

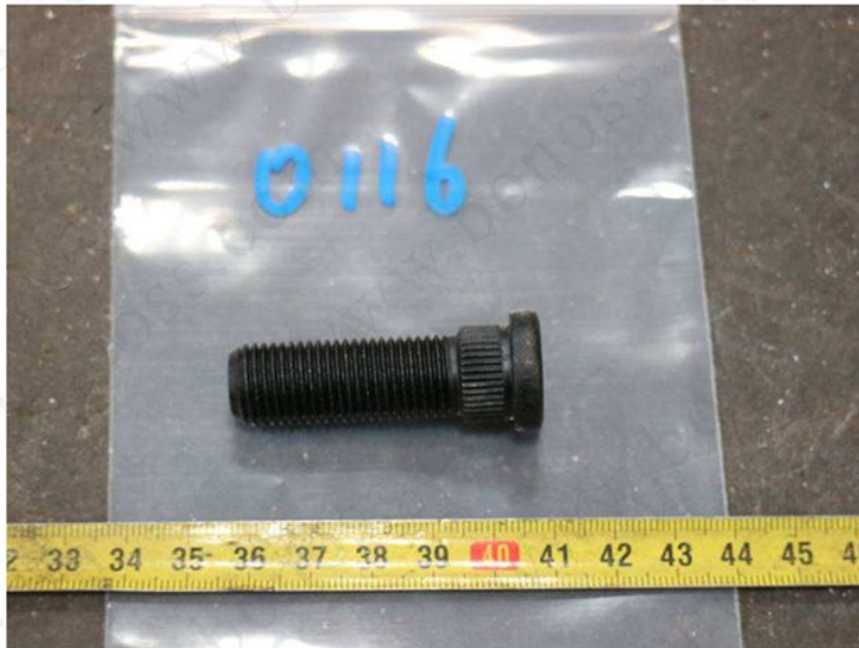
Sample photo(s):

Sample description: A piece of steel bolt

Other information: Product specification: M14*1.5, 12.9;
Material and Mark: SCM440.

Element	C	Si	Mn	P	S	Cr	Ni	Mo	Cu
Result,%	0.41	0.21	0.68	0.012	0.005	0.98	0.016	0.16	0.016
