Test Report No.: 01 220 CHN/T-2202932

# Test Report

**Sample name:** BONOSS WHEEL NUTS

**Other information:** Product specification: M12\*1.5 Grade 12;  
Material and Mark: 50BV30.

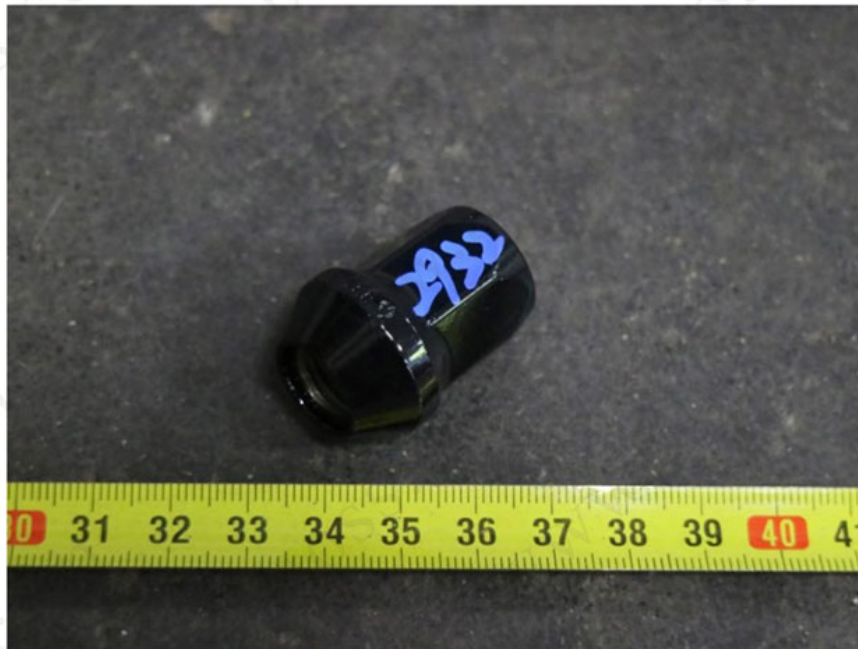
**Sample photo(s):**

**Sample description:** A piece of steel nut

Element	C	Si	Mn	P	S	Cr	Mo	Ni	Cu
Result, %	0.30	0.071	0.88	0.012	0.005	0.42	0.009	0.018	0.030

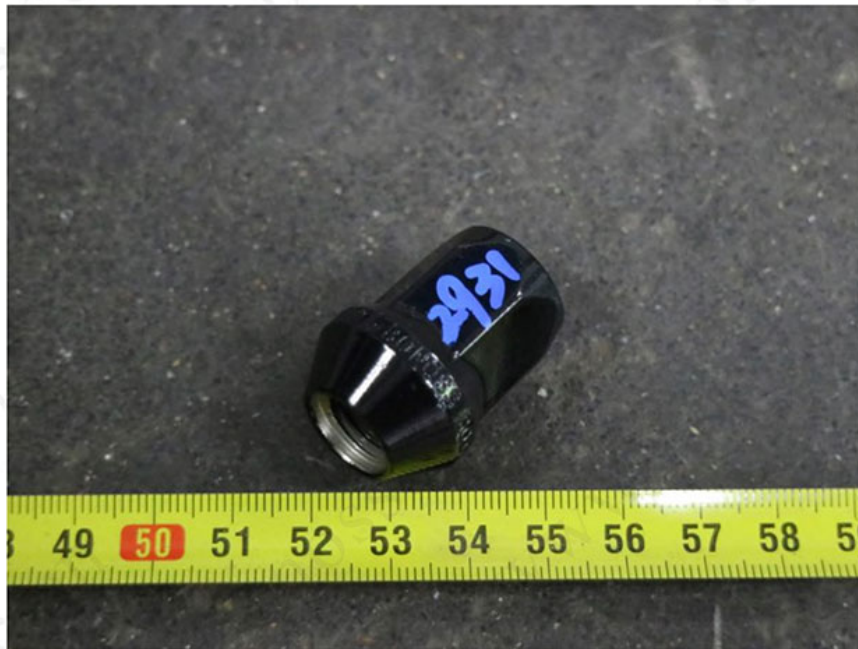
**Sample photo(s):**

**Sample description:** A piece of steel nut

**Other information:** Product specification: M12\*1.5 Grade 12;  
Material and Mark: 50BV30.

Test conditions	Result
A proof load 105.7kN shall be applied and shall be maintained for 15 s and then released.	No fracture by thread stripping or nut fracture. The nut was removed using the fingers from the test mandrel after test.
